Three Rivers Rowing Association
Pittsburgh, PA

Greater Lakes EZ-Dock
Joel Kanick
716-773-7063 x107
JKanick@AnchorMarina.com

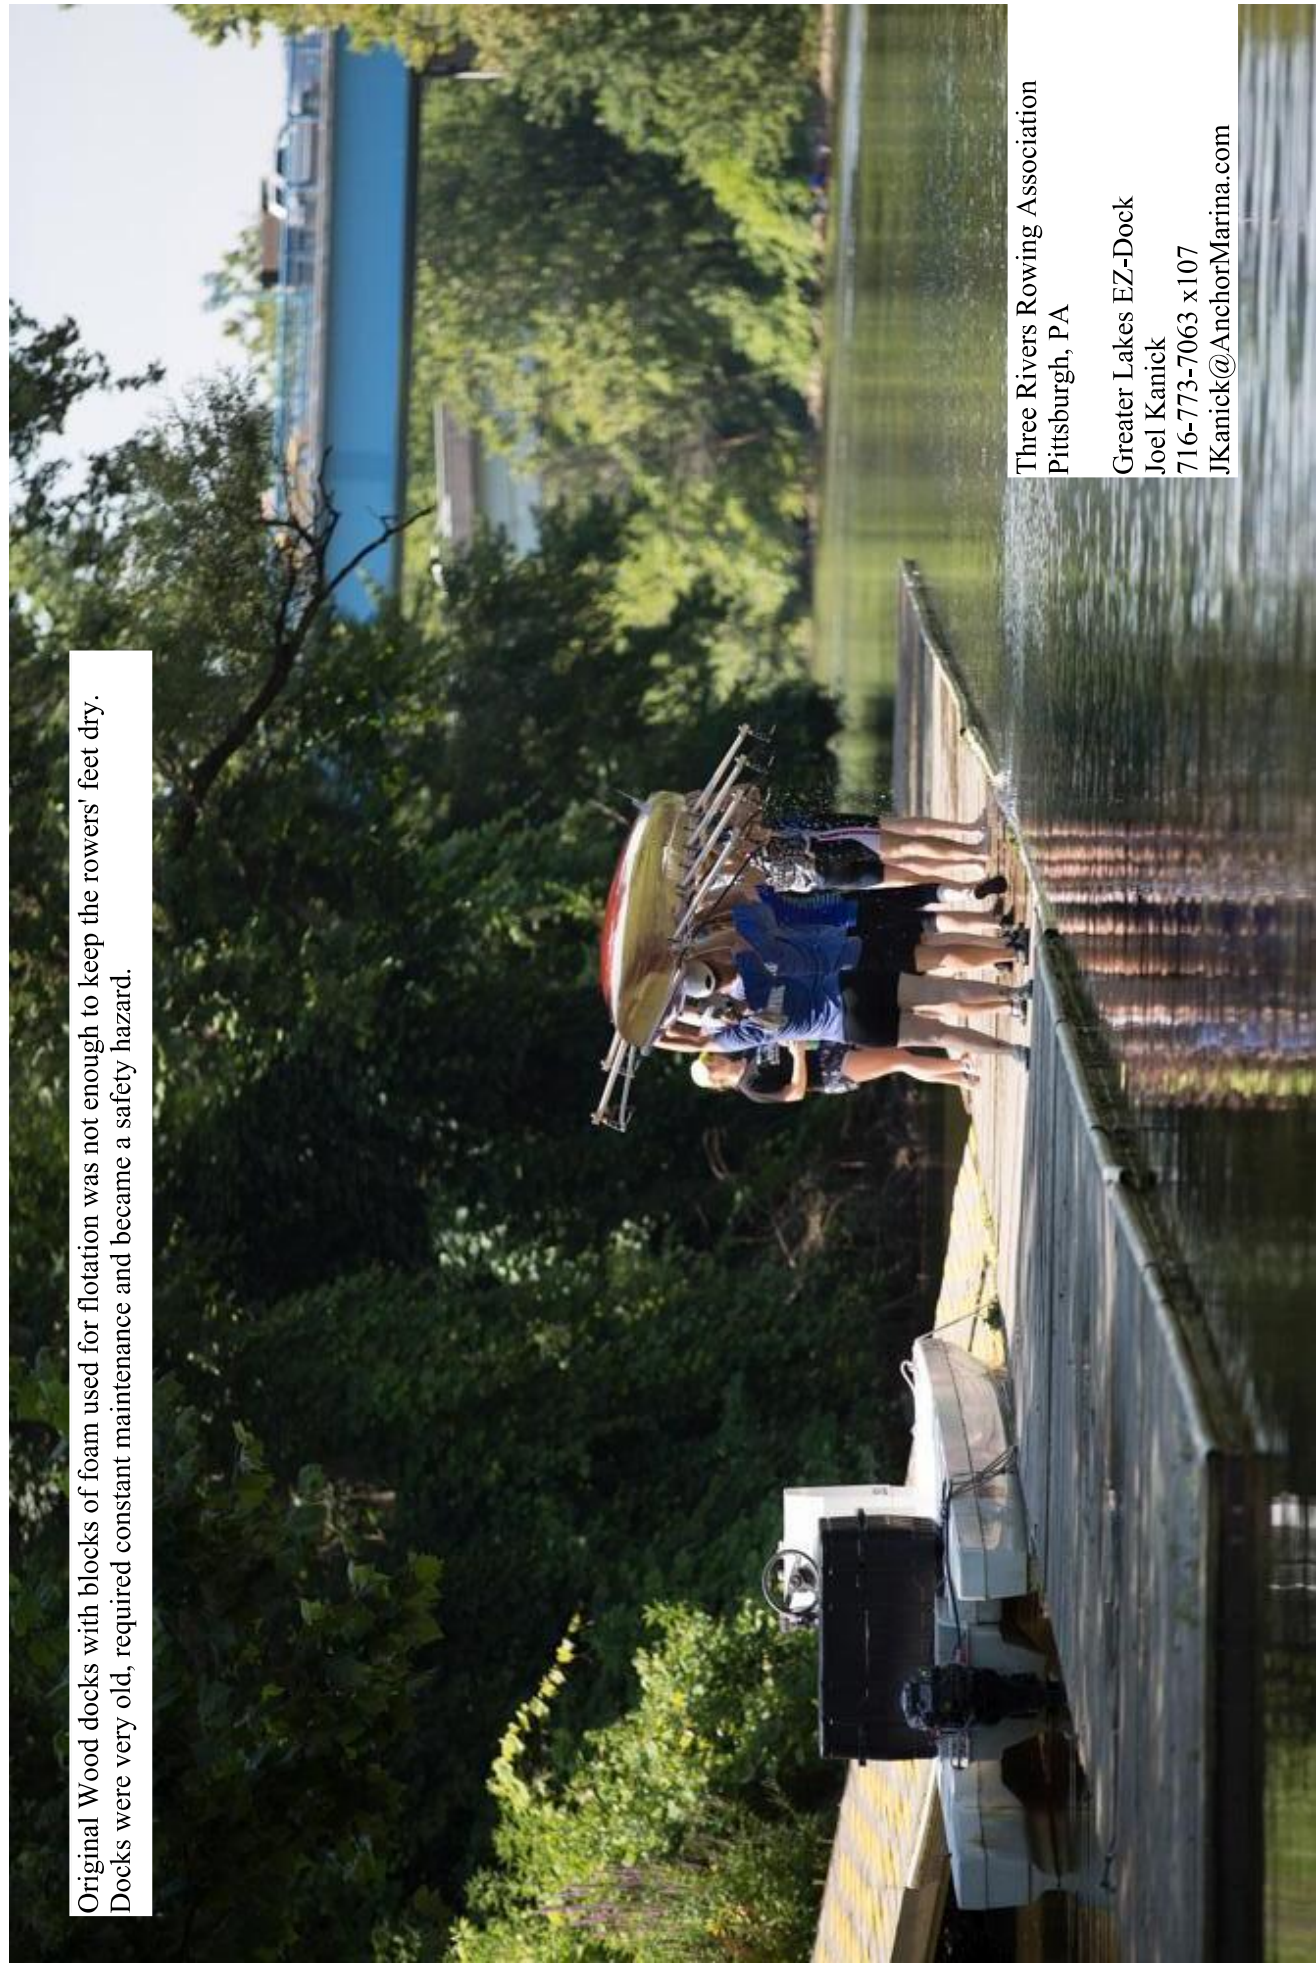
Original Wood docks with blocks of foam used for flotation was not enough to keep the rowers' feet dry. Docks were very old, required constant maintenance and became a safety hazard.

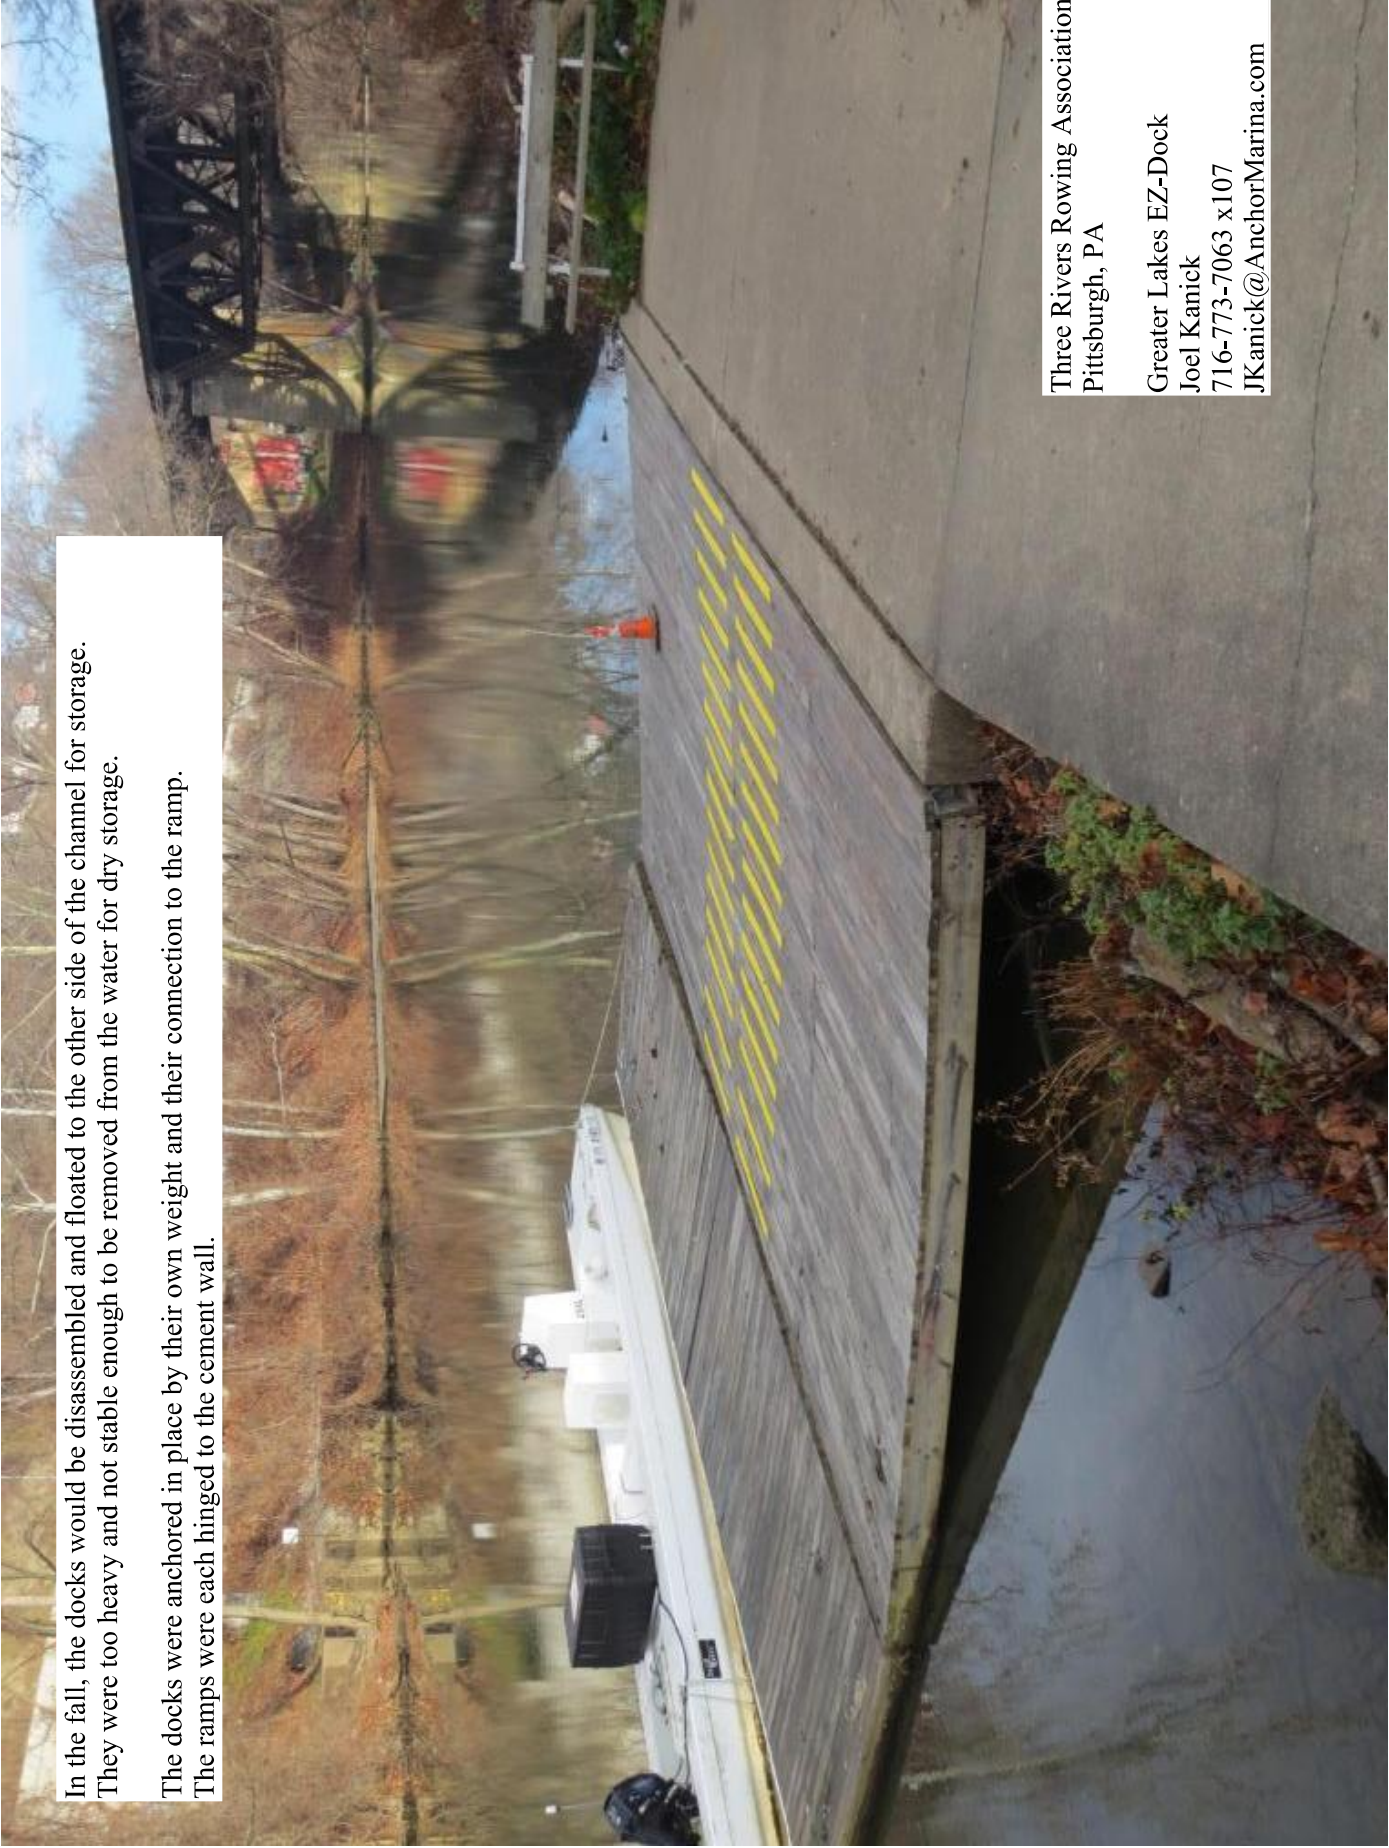
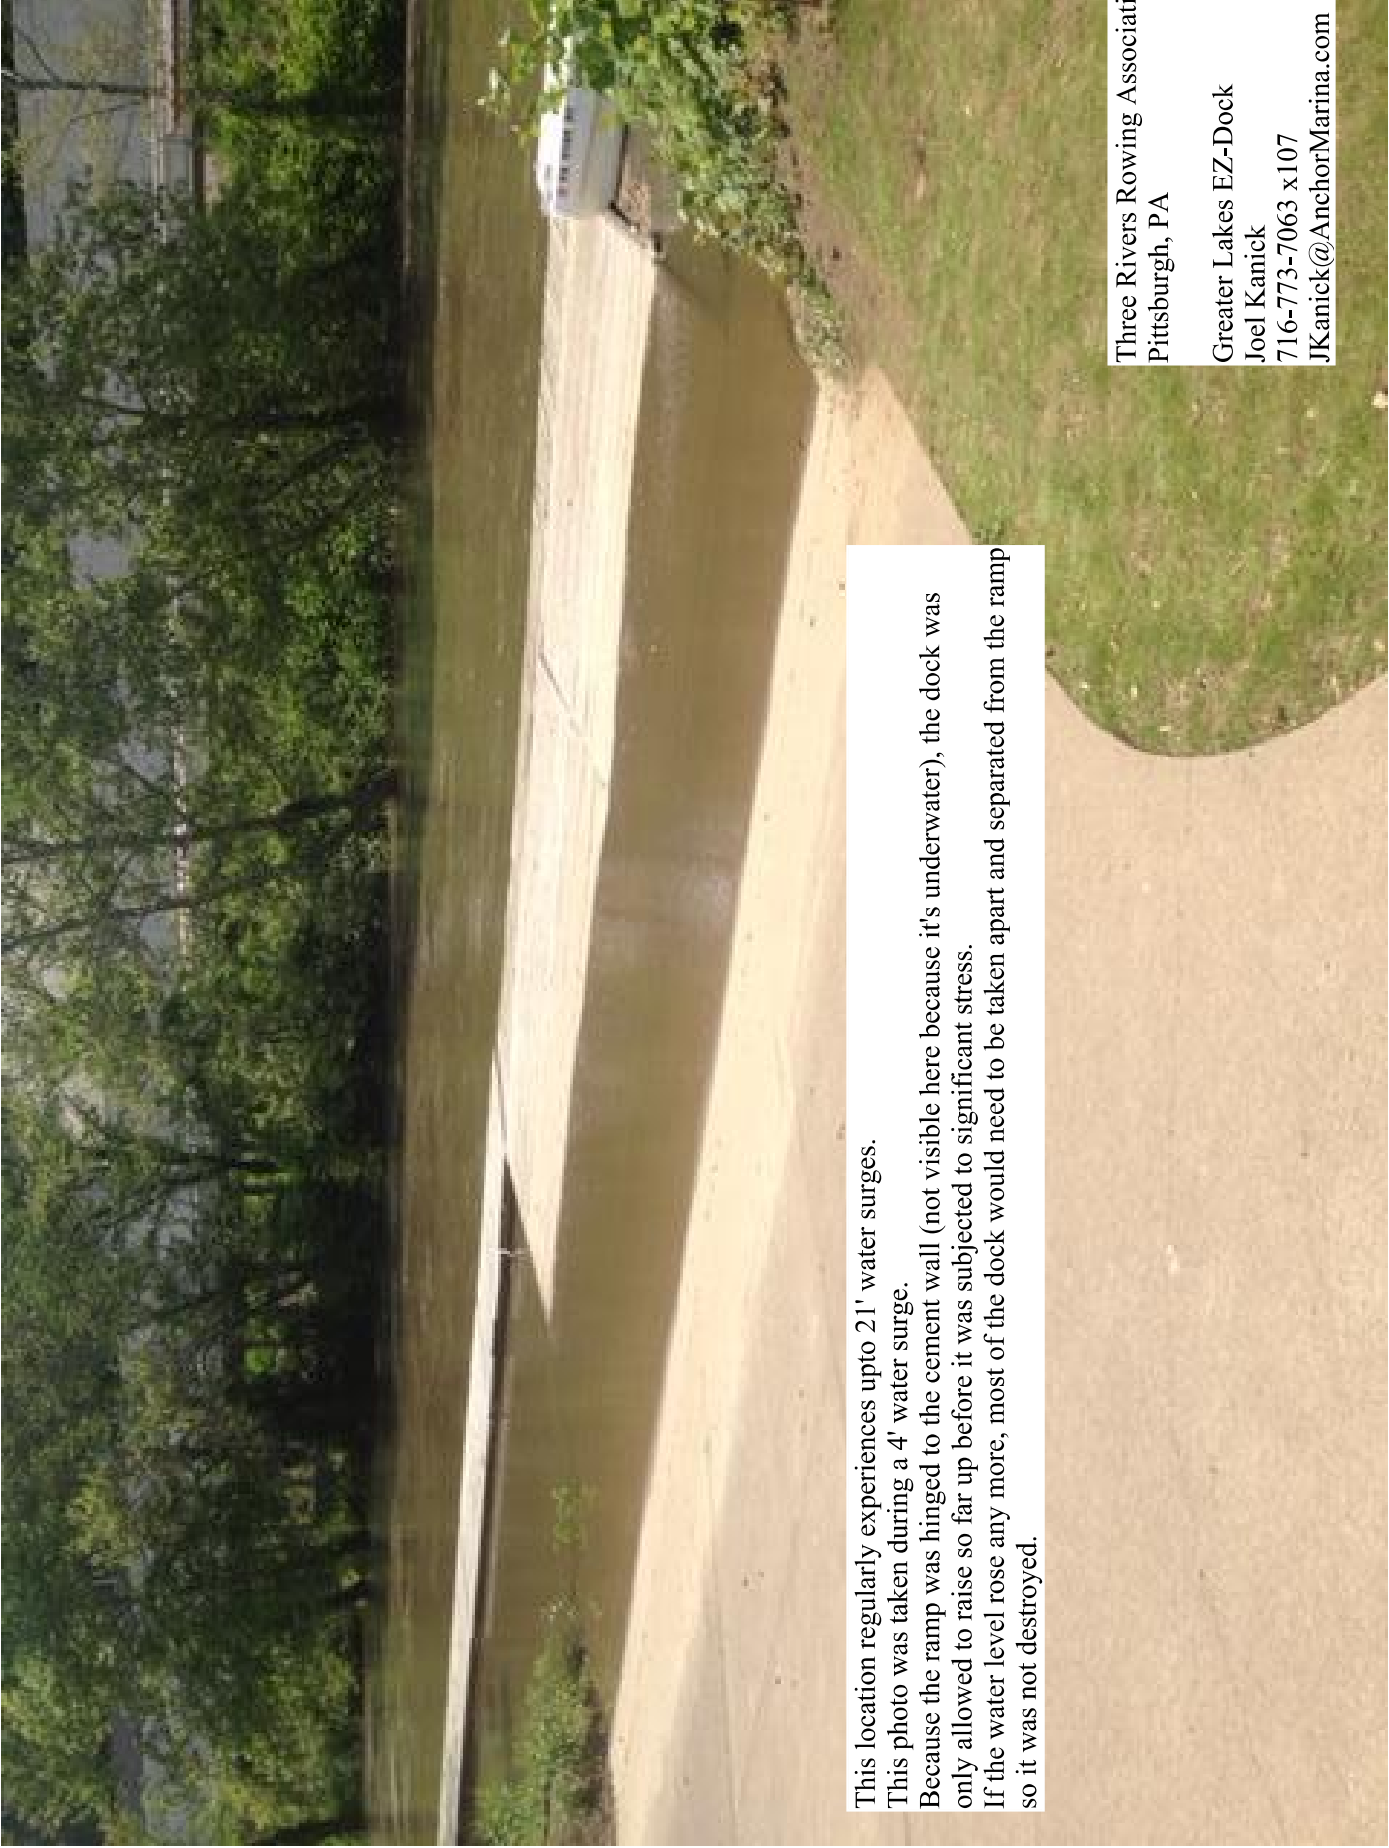
In the fall, the docks would be disassembled and floated to the other side of the channel for storage. They were too heavy and not stable enough to be removed from the water for dry storage.

The docks were anchored in place by their own weight and their connection to the ramp. The ramps were each hinged to the cement wall.

This location regularly experiences upto 21' water surges. This photo was taken during a 4' water surge. Because the ramp was hinged to the cement wall (not visible here because it's underwater), the dock was only allowed to raise so far up before it was subjected to significant stress. If the water level rose any more, most of the dock would need to be taken apart and separated from the ramp so it was not destroyed.

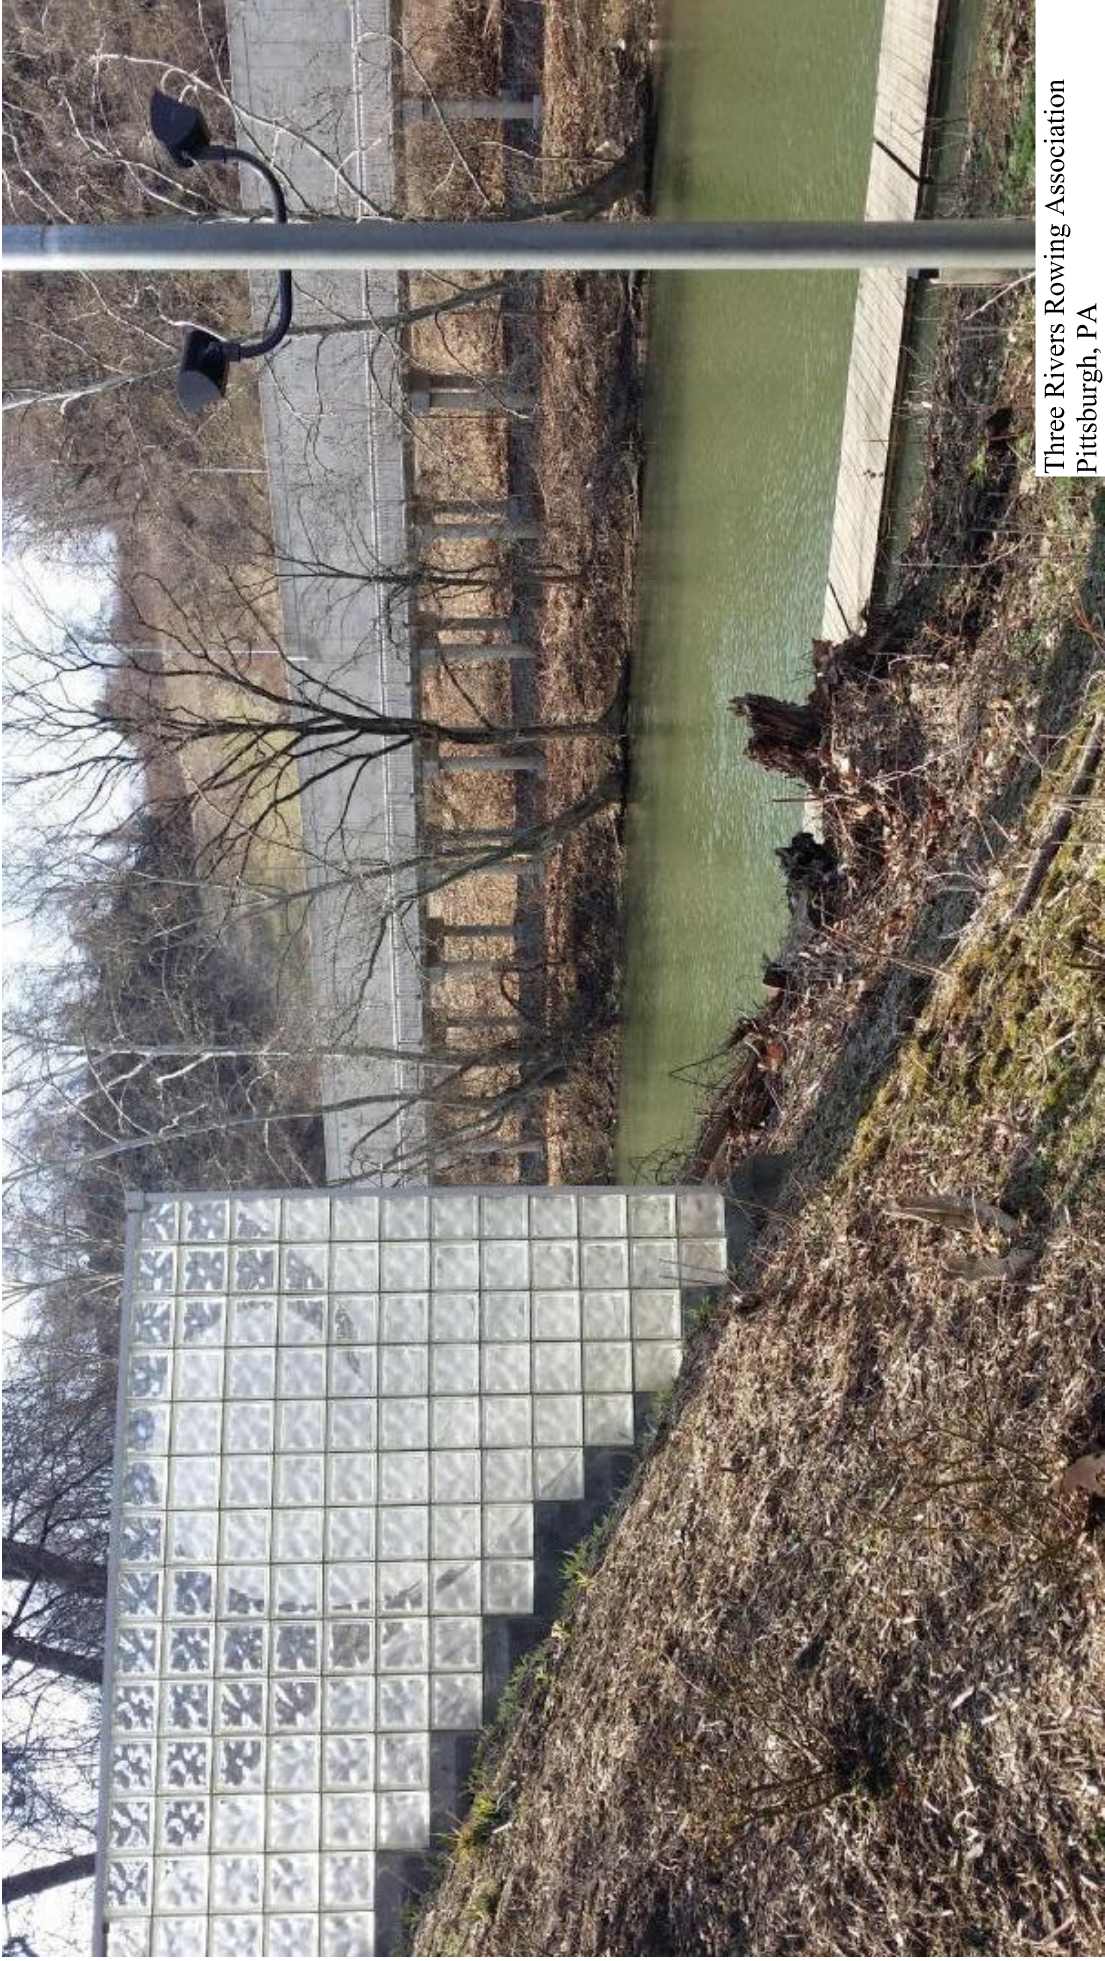
The top of this glass block wall represents an 18' water surge level.
This wall is completely covered by water multiple times each year.

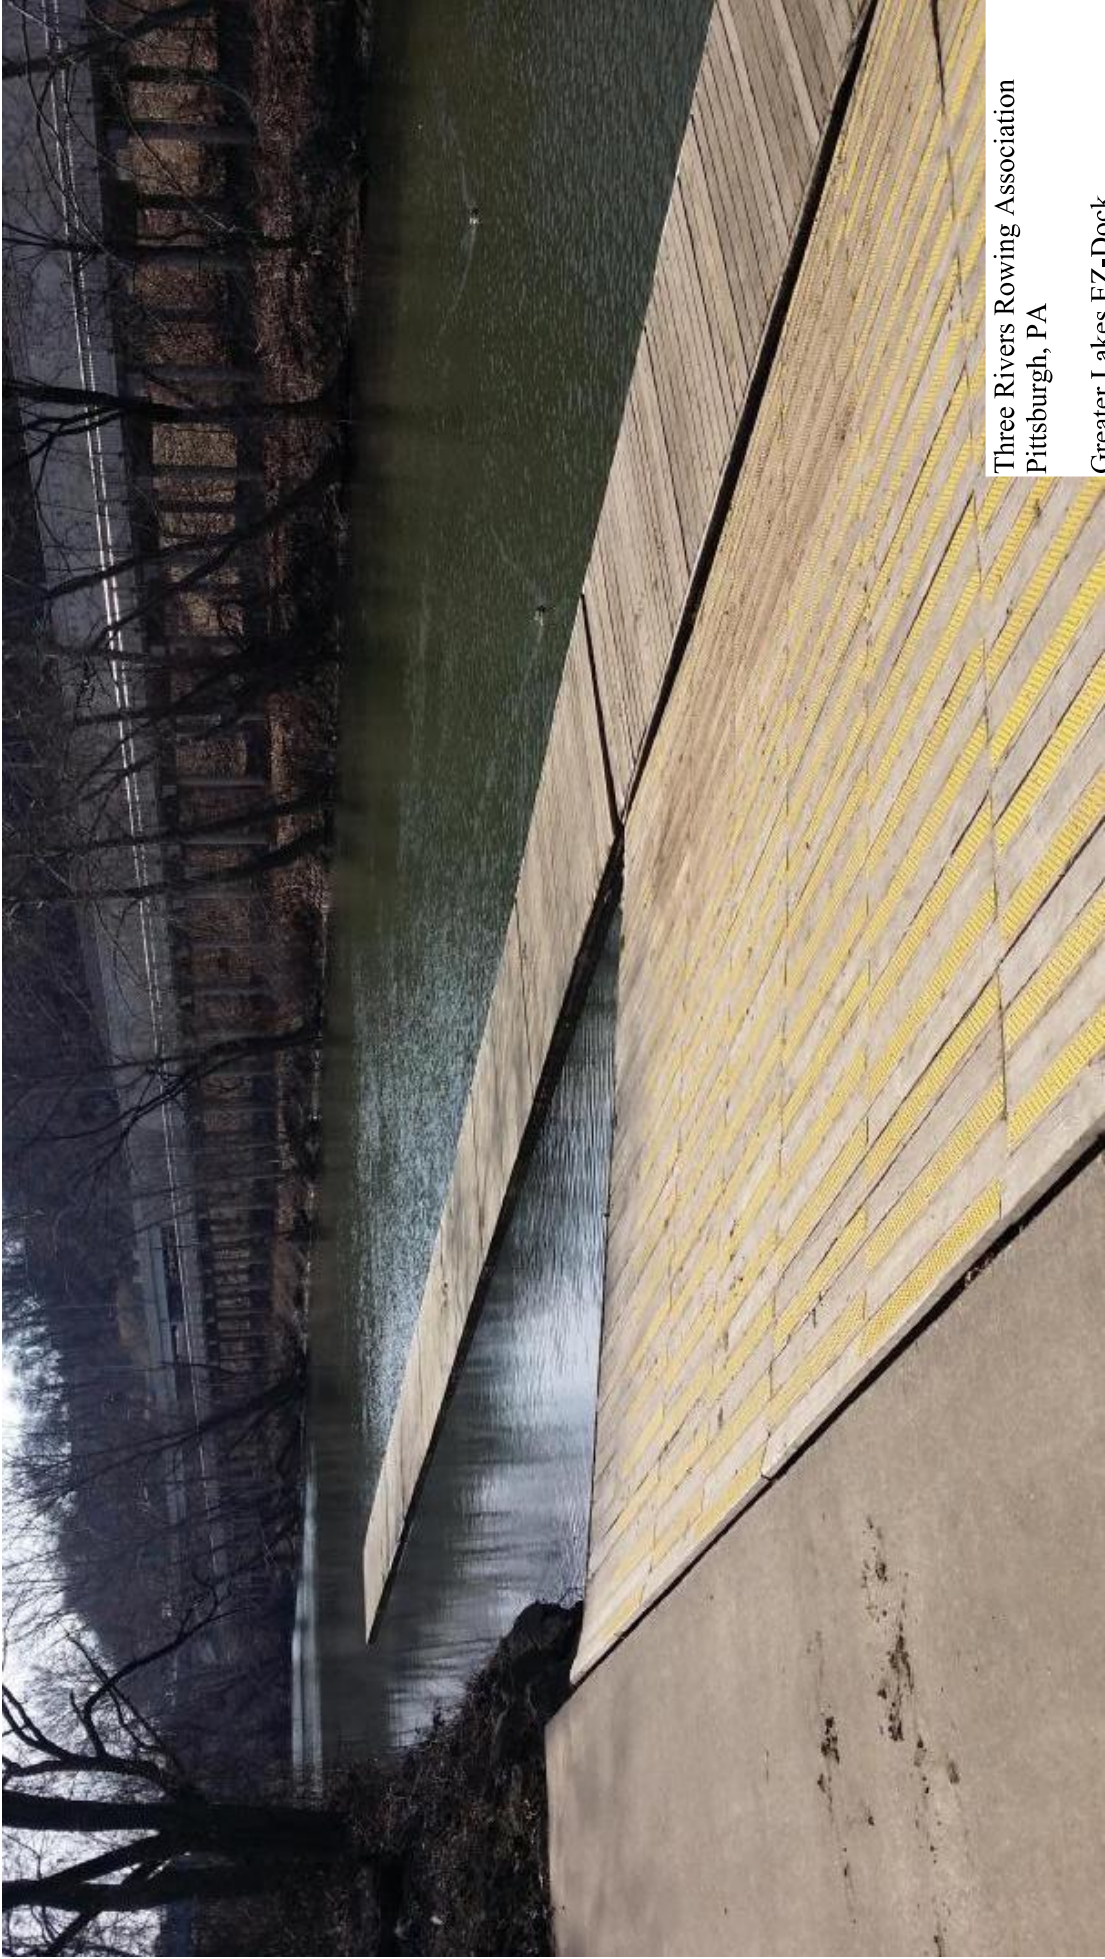
Downstream dock in normal water conditions.

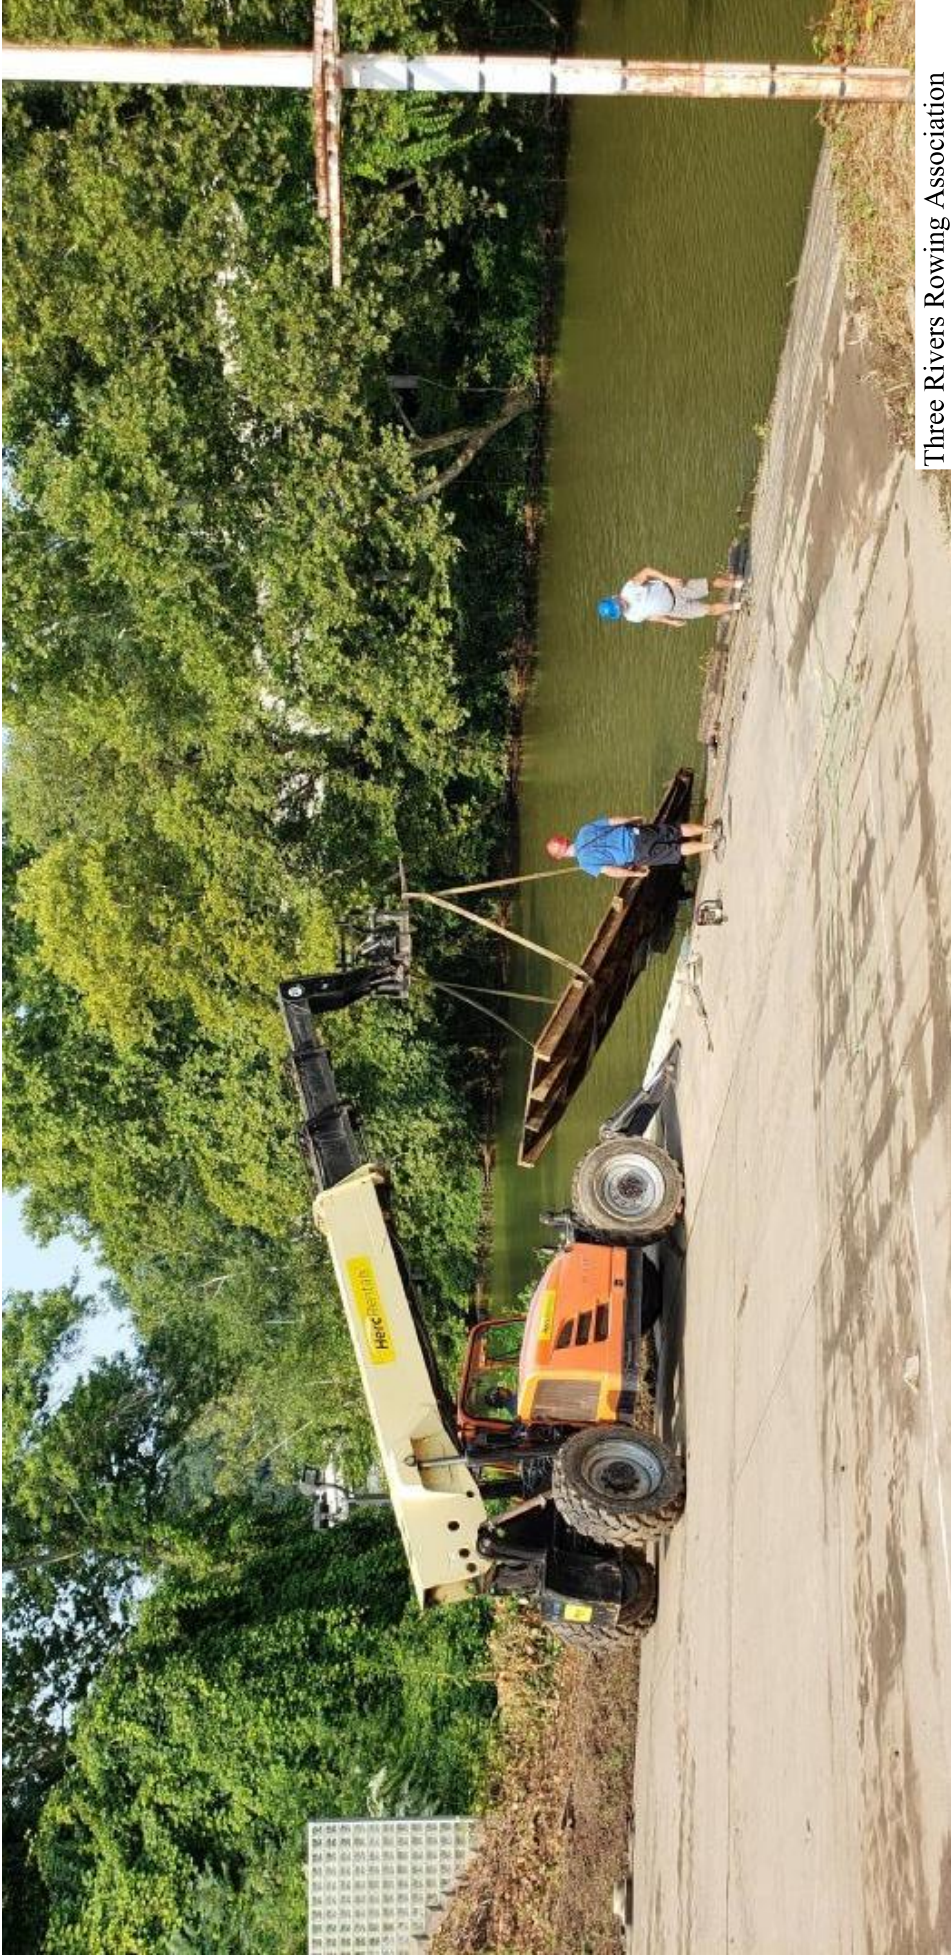
Each ramp and dock needed to be removed 1 piece at a time.
Once out of the water, the foam floats simply fell to the ground in pieces.
Each piece of dock crumbled because it was completely water-logged.

Both docks and ramps were removed by our team of 8 employees in less than 5 hours.

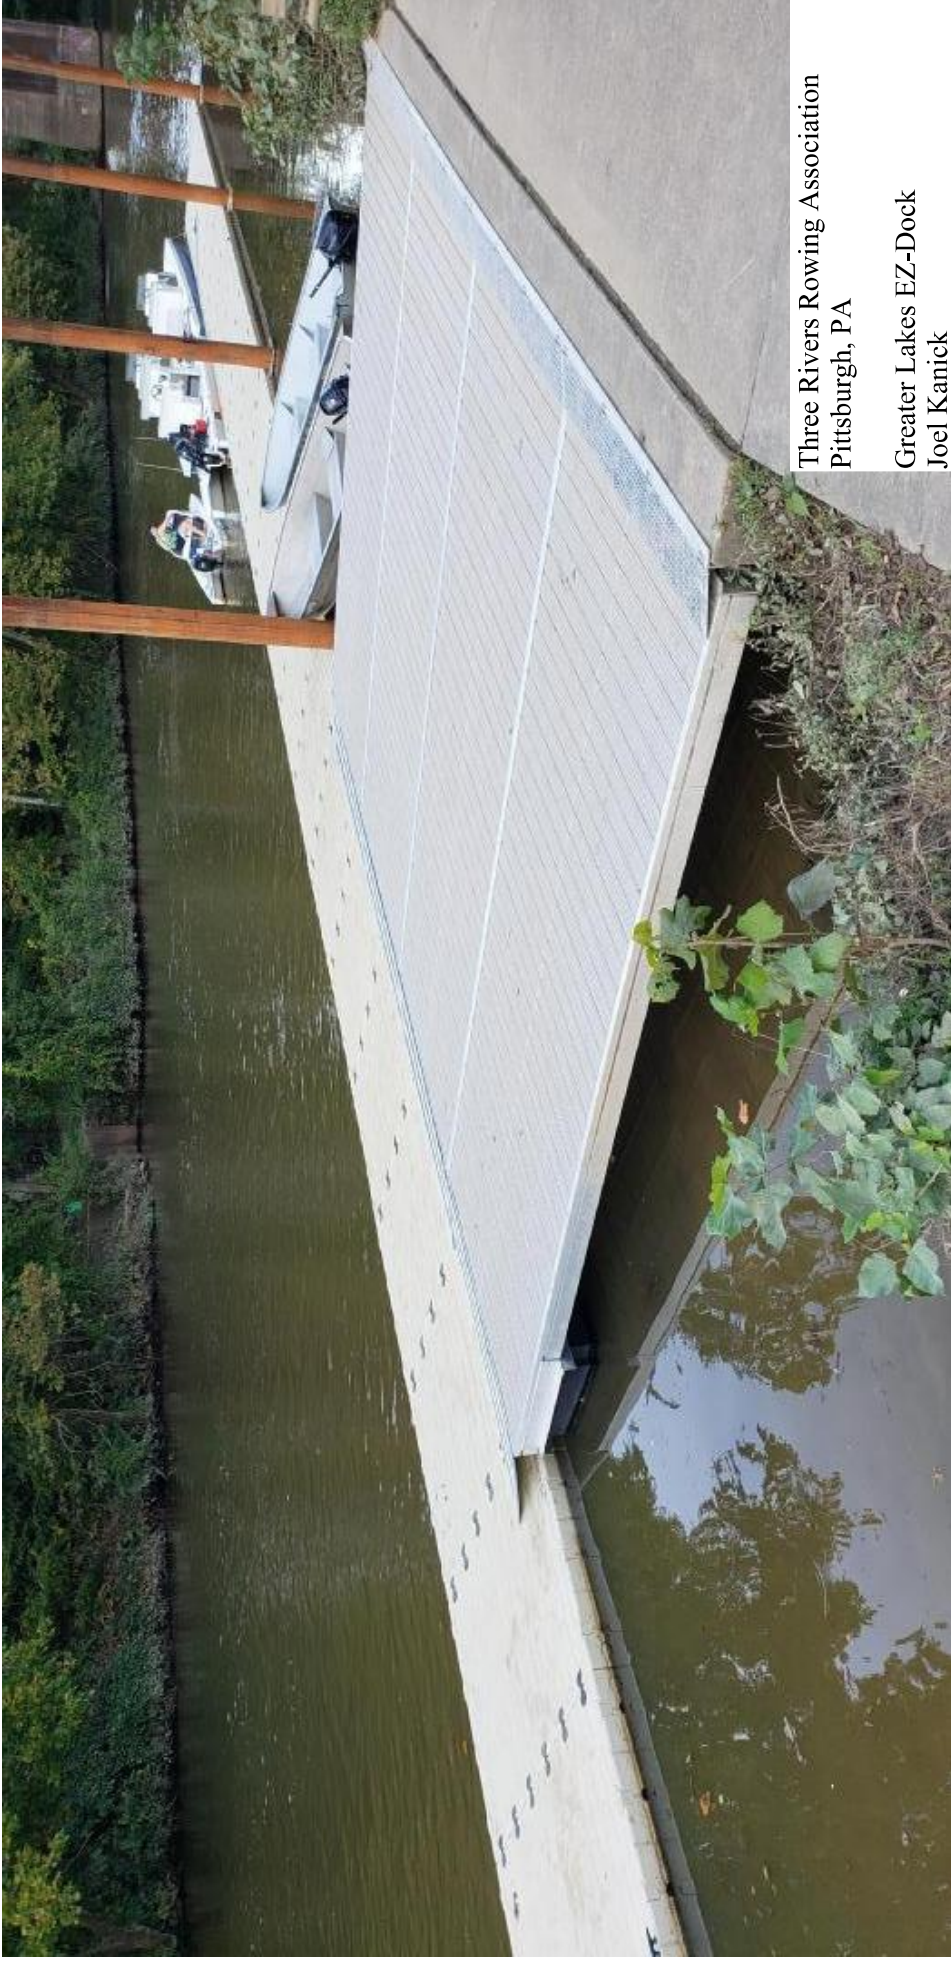
Each Ramp was custom made to be 20 long' x 32' wide.

Each ramp has it's own flotation and floats separately from the EZ-Dock.

This is necessary because each ramp is hinged to the existing cement wall allowing only 1 side to float up when the water surges. Whereas the EZ-Dock will float up as high as the water will surge.

These ramps and docks will remain in place all year.

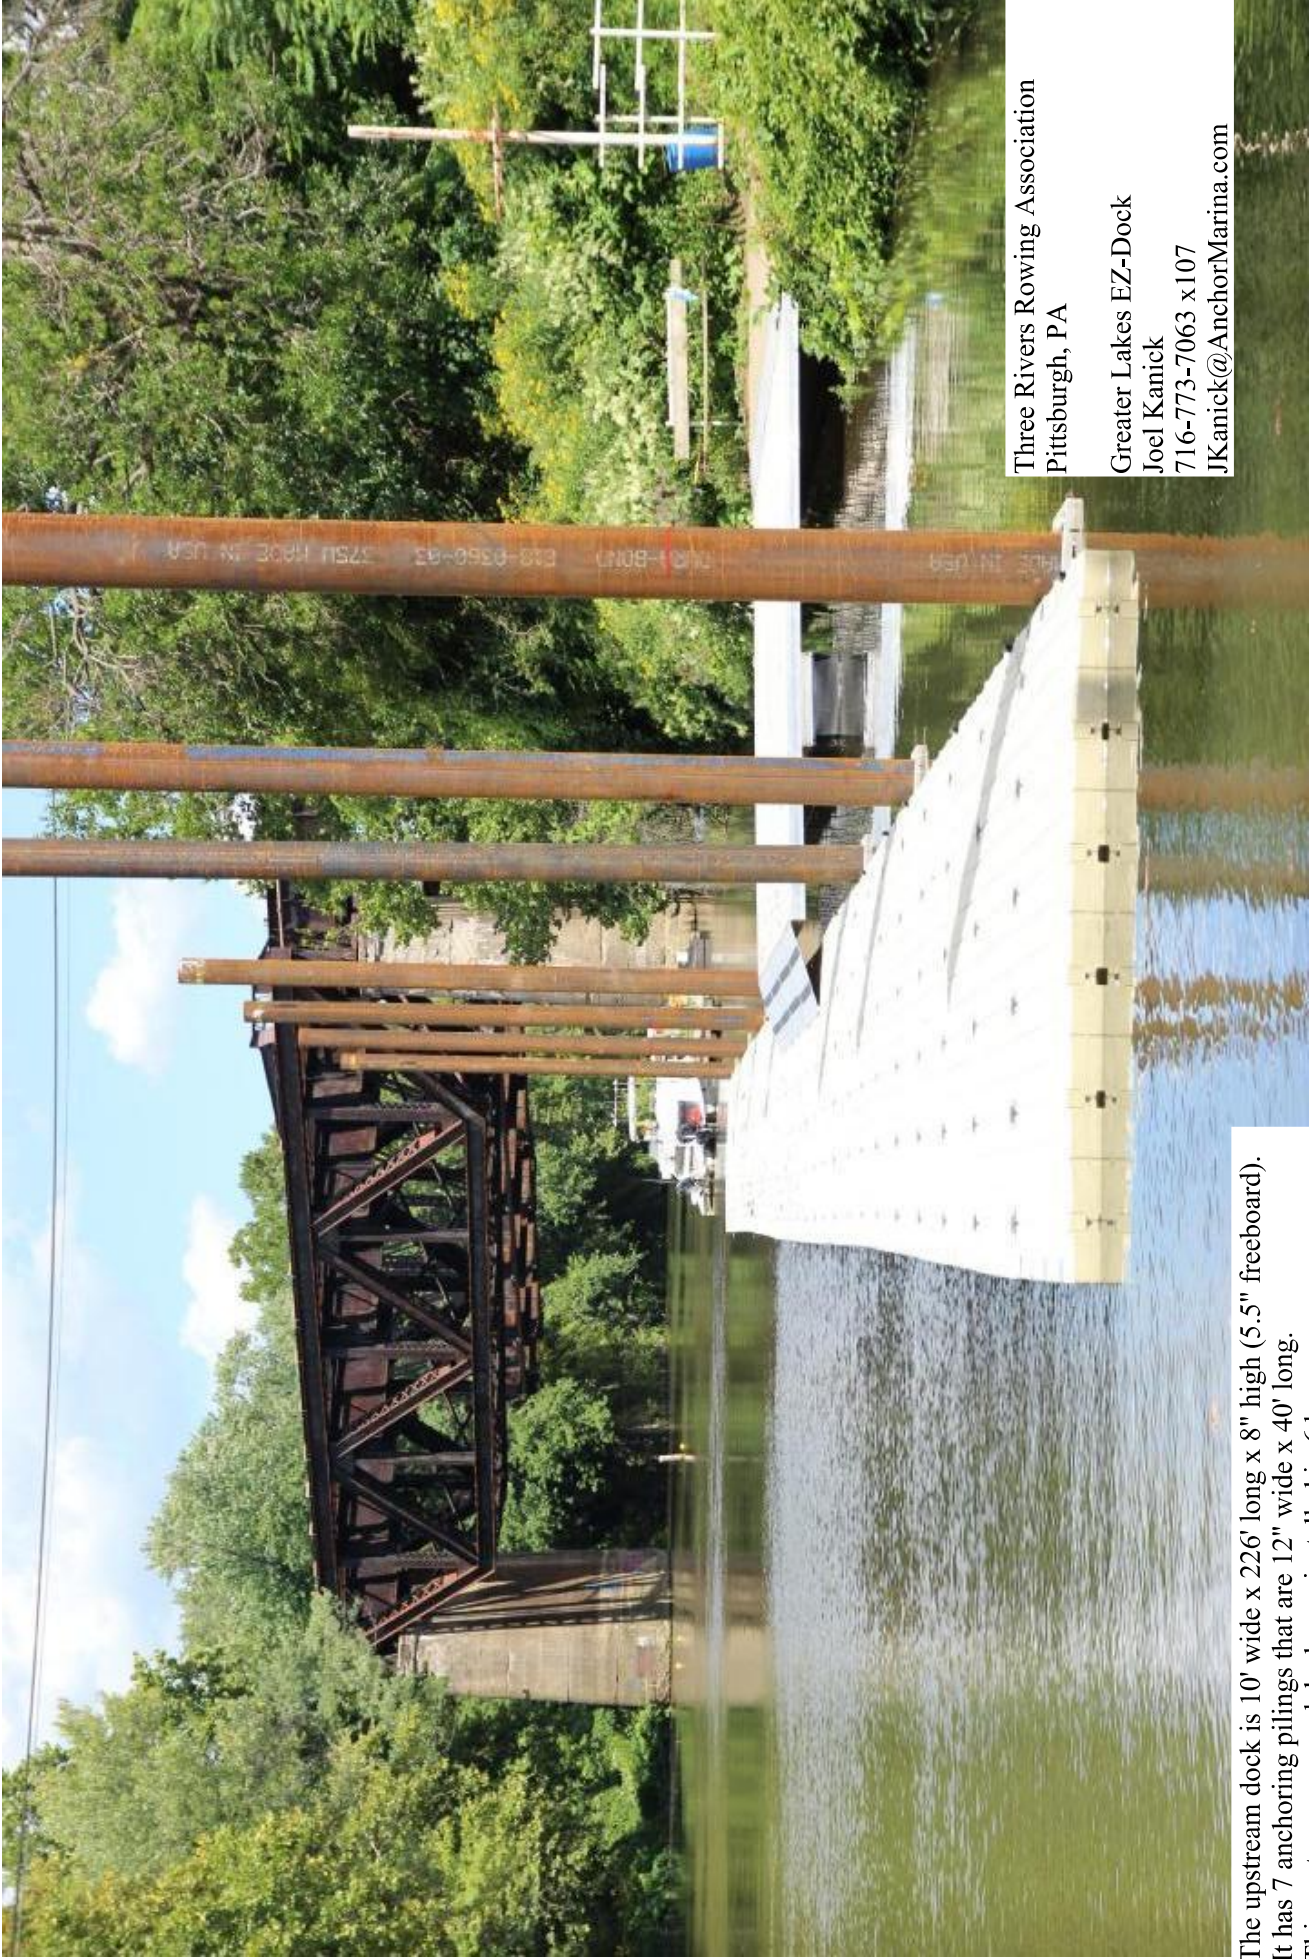
The upstream dock is 10' wide x 226' long x 8" high (5.5" freeboard). It has 7 anchoring pilings that are 12" wide x 40' long. This custom ramp and dock was installed in 6 hours.

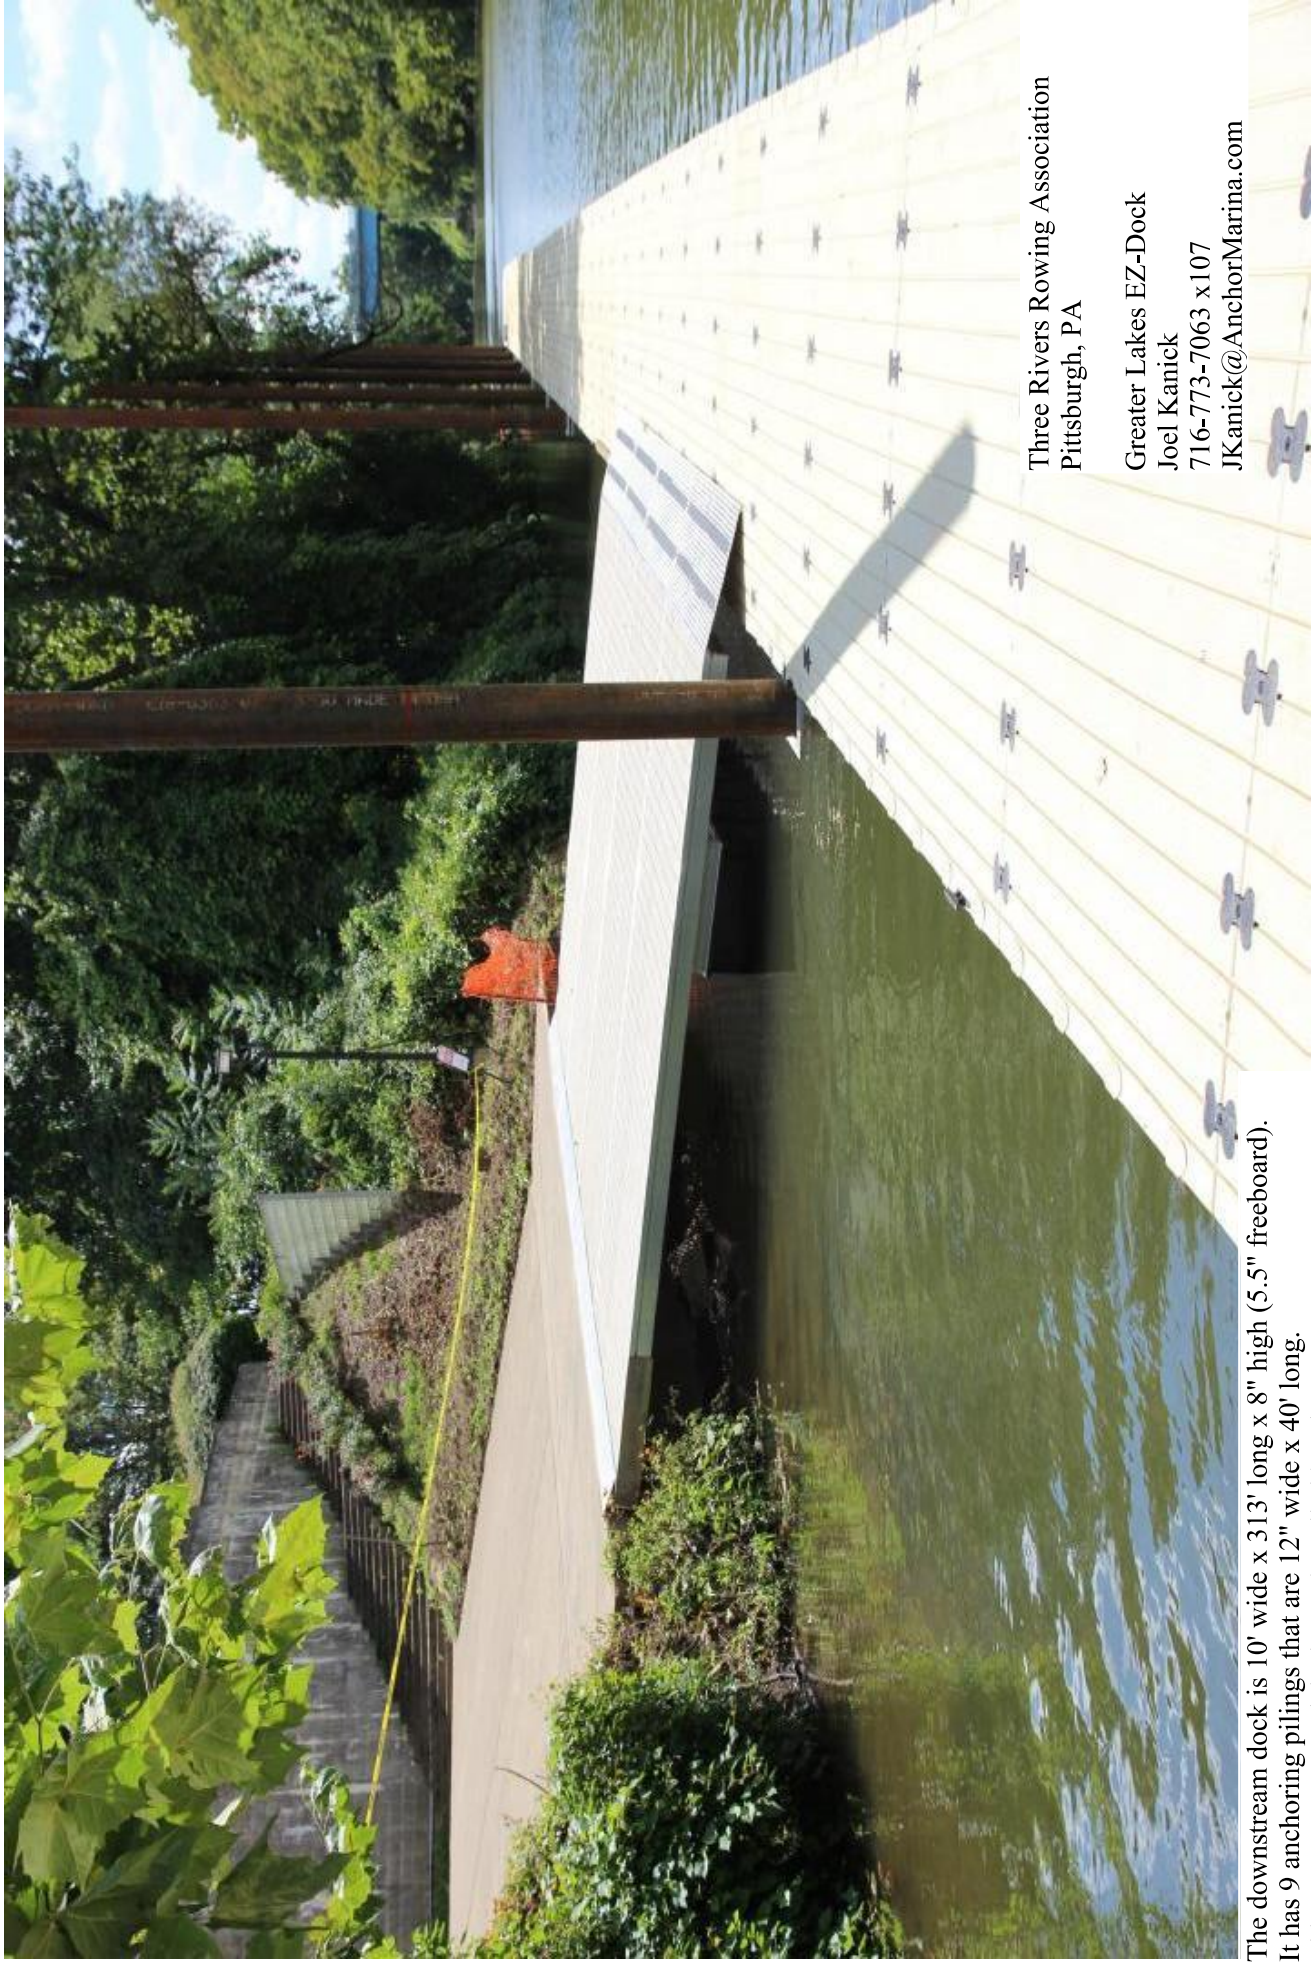
The downstream dock is 10' wide x 313' long x 8" high (5.5" freeboard).
It has 9 anchoring pilings that are 12" wide x 40' long.
This custom ramp and dock was installed in 6 hours.
